NASA Technical Memorandum 104627

Degradation of FEP Thermal Control Materials Returned from the Hubble Space Telescope

DECEMBER 1995

Goddard Space Flight Center
Greenbelt, Maryland 20771

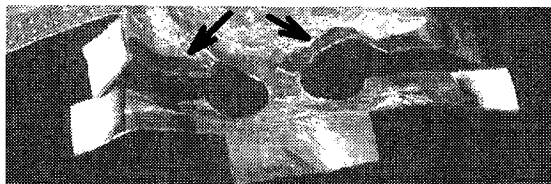
Both magnetometer MLI sections show a very dark discoloration in the areas of highest solar fluence. These dark areas appear in proximity to an underlying acrylic transfer film adhesive layer. The transfer adhesive is applied in 1.3 cm widths along the edges of the FEP layer. This is the approximate width of the darkened zone. The combination of thermal effects and UV induced degradation are thought to have caused this browning. Figure 6 shows the darkened areas for one of the two magnetometer MLI assemblies.

Figure 6: Solar induced browning of a magnetometer MLI. Acrylic tape is used in this area to fasten the top FEP layer to the second layer in this MLI assembly.

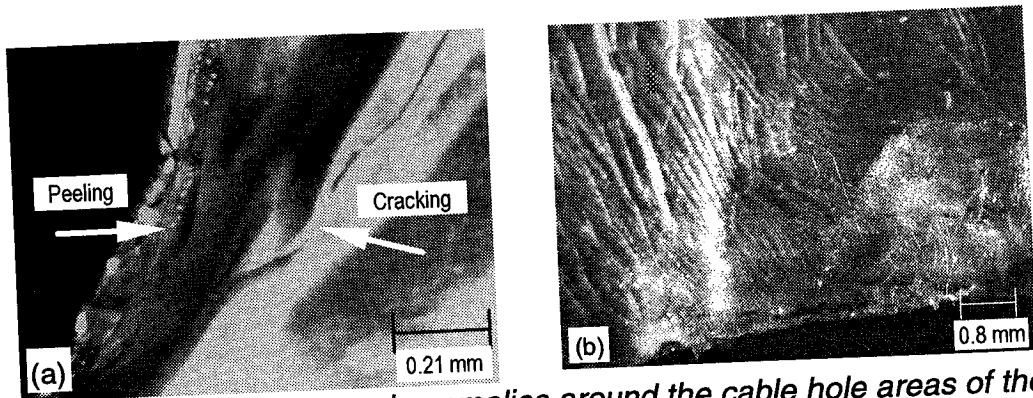
In addition to discoloration, areas of separation or peeling of the FEP film from the acrylic adhesive, and cracks in the FEP are apparent. The peeling and cracking are more pronounced on the surfaces of the magnetometer MLI with highest solar fluence. Figure 7 shows the peeling and cracking phenomena noticed in the cable areas of the FEP layer of the magnetometer MLI.

Figure 7: Photographs of observed anomalies around the cable hole areas of the magnetometer MLI. (a) Area of magnetometer MLI showing peeling and cracking of the FEP layer. (b) Area of the MLI surface showing severe cracking.

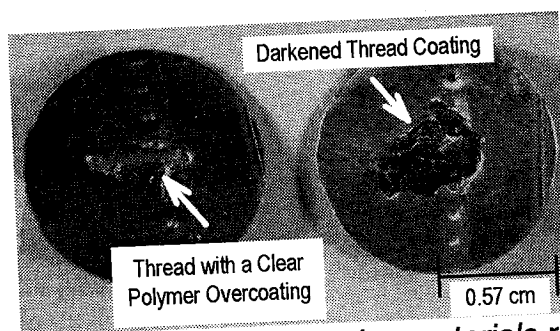
The overall appearance of this blanket assembly looked good except for the apparent browning of a silicone polymer used as a thread coating (see Fig. 8), and visible through-thickness cracks (see Fig. 9). A slight milky appearance was also present. These anomalies were noted in areas of high solar exposure. Modeling of the SA-I drive arm MLI to calculate solar exposure has not yet been performed. The cracks were noted at KSC during the de-integration of the hardware, before contact or any other handling was performed on the blanket assembly.

Figure 8: Comparison of the polymer thread coating materials removed from the SA-I MLI. The coating on the left is relatively undarkened, and the thread and MLI features are still visible. The coating on the right has darkened significantly. The thread is faintly visible through the coating. The sample on the left received a lower solar fluence than the sample on the right.

The darkened silicone thread protective material pictured on the right in Figure 8 was found to contain SiO_x and a small amount of fluorine. Adjacent to the polymer overcoat, the oxidized FEP substrate and trace amounts of silicon were found. The thread area itself contained only SiO_x and silicone.

In comparison, the sample with the clear thread coating (see Fig. 8) was analyzed. Adjacent to the coating, carbon, fluorine and a small amount of oxygen were noted. The clear coating was found to contain only silicon, carbon, and oxygen. No fluorine was detected. The oxygen content measured in the undarkened sample was considerably lower than that of the darkened sample.

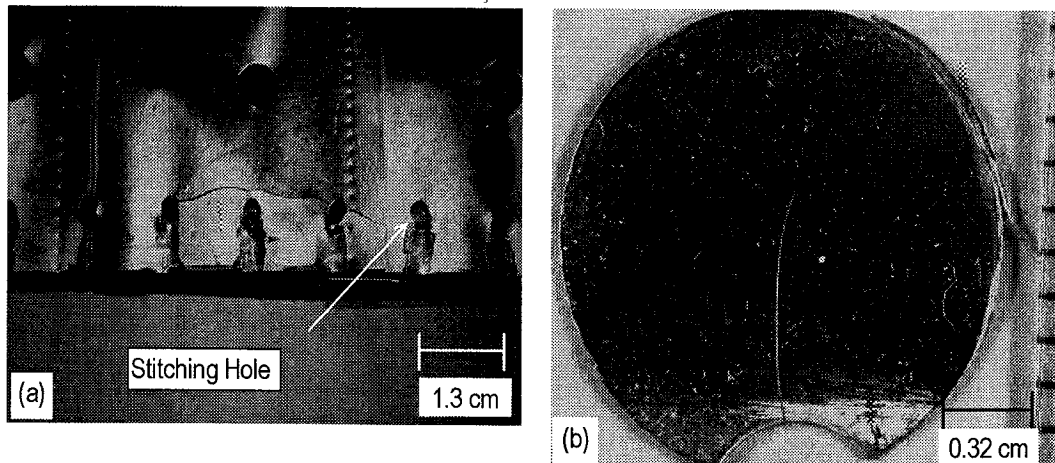
Figure 9: Areas of through-thickness cracking on the SA-I MLI. (a) Cracks are pictured near the edge of the blanket assembly. This is the area where the two mating sides were sewn together. (b) A cracked area sampled near one of the vent holes.

Two vent hole areas showing through thickness cracks (similar to the crack of Figure 9b) were examined to see if chemical changes in the FEP material may have induced the cracking. The results vary between the two samples. For one sample, the analysis directly on the cracked area showed fragmented carbon-fluorine bonds, and less oxygen than an area adjacent to the cracked area. The second sample showed equivalent chemistry between cracked and uncracked areas.

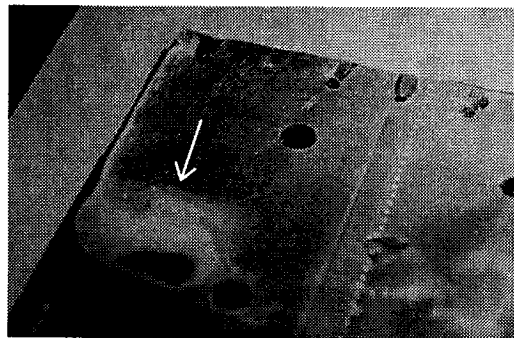
Figure 10: The largest localized area of contamination in the SA-I drive arm MLI is shown in this photograph.

Analysis of the large area of discoloration in Figure 10 showed the major constituent of the residue to be hydrocarbon based materials. This is the only area where hydrocarbons are predominant in the residue. Away from the center of the contaminated area, the FEP substrate, and small amounts of silicon and oxygen are present.

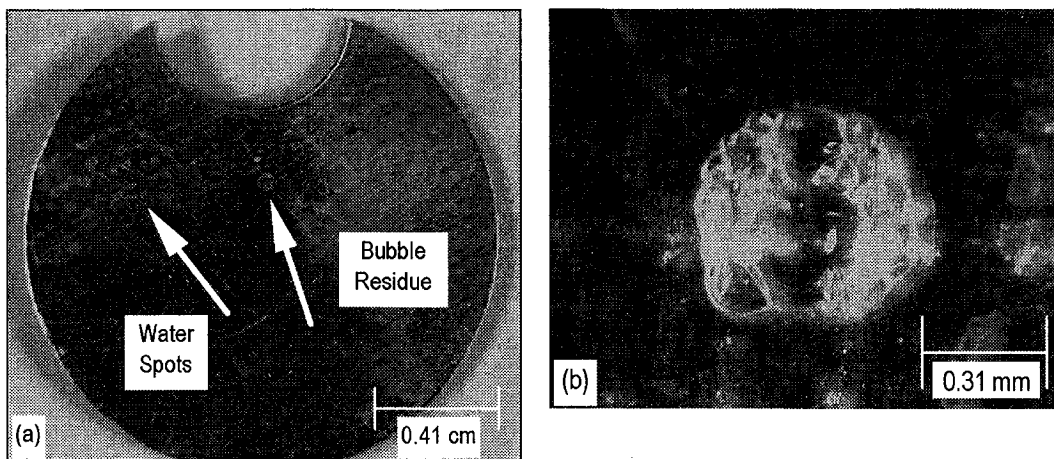
Figure 11: Indication of a pre-flight wiping operation is shown in these photographs. (a) Liquid droplet trails are evident in this picture leaving behind what is being termed “water spots”. In proximity to the water spots, a bubble residue was located. (b) Enlargement of the bubble residue.

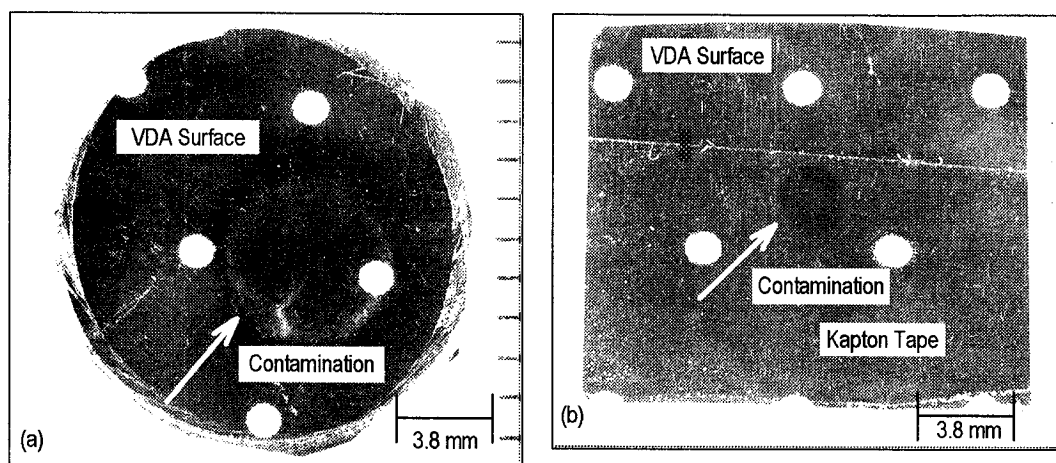
The second layer of the SA-I drive arm MLI assembly was also sectioned and analyzed in two areas (see Figures 12a-b). The sample in Figure 12a was taken from an area exposed to the space environment below a vent hole in the top FEP layer. The sample in Figure 12b was taken below a stitching hole in the MLI assembly. The results from the XPS analysis show the presence of fluorine, silicone, and SiO_x on the VDA and Kapton surfaces.

Figure 12: Second layer contamination from the SA-I MLI. The second layer is a Kapton substrate with both sides coated with VDA. The contaminants are predominantly fluorine, silicone and SiO_x . (a) This section was removed from underneath a vent hole in the FEP layer. (b) This sample was removed below a stitching hole (see Fig. 9a). The area of contamination is located on a piece of Kapton tape that has been applied to the VDA surface.

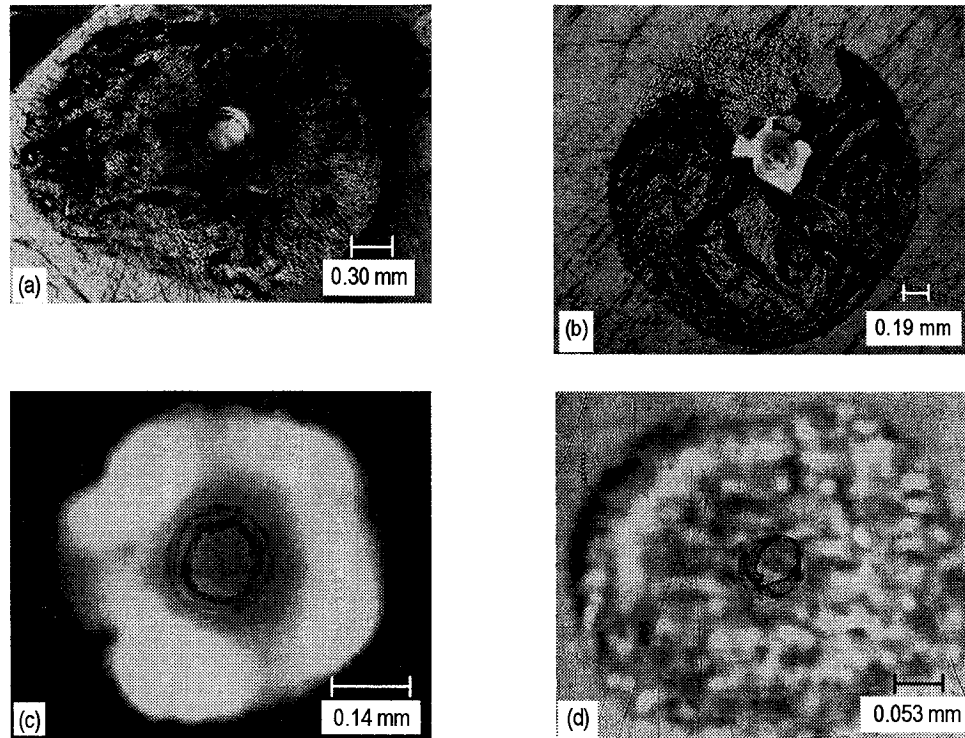
Six MMD impact holes were found on the SA-I MLI. Examination was performed with optical microscopy up to 200x magnification. The largest “shock ring”, or impact affected area was found on the solar facing surfaces of the MLI. Other samples were taken from material that was wrapped around the circular drive arm, and pointed away from the sun. It has not yet been determined if the shock ring size can be correlated to the embrittlement of the FEP material, or if is just a function of particle size. Figure 13 shows 4 of the 6 observed impact sites for the SA-I drive arm FEP layer. For the areas of high

solar exposure, the shock ring is over 7 times the diameter of the impact hole. For the areas of lower solar exposure, the shock ring is roughly 4.5 times the diameter of the impact hole.

Figure 13: MMD impact sites from the FEP layer of the SA-I MLI. Samples (a) and (b) were removed from an area of the MLI that was predominantly solar facing. Sample (c) and (d) were removed from areas of lower solar fluence.

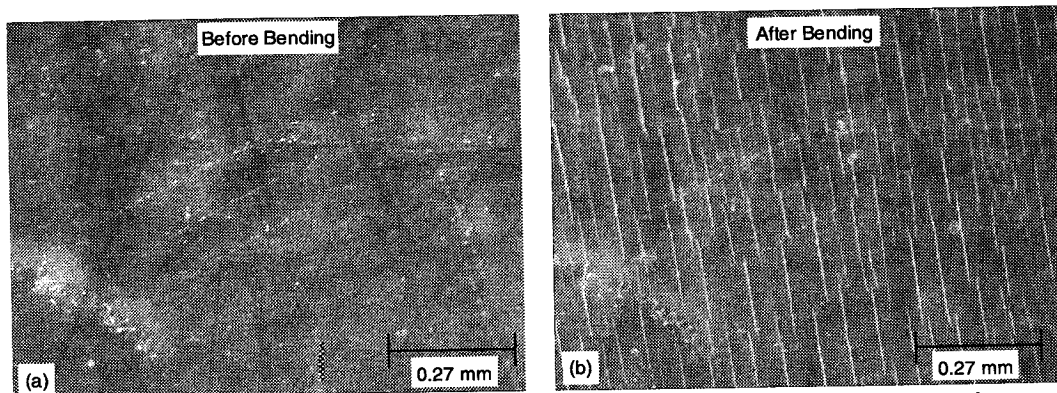
A two step bending process was another method used to evaluate the extent of embrittlement of the SA-I MLI FEP material. Small sections, roughly 2 cm on each side, were cut from the FEP layer. The samples were subjected to folding, or bending around an 0.83 mm diameter mandrel. In one direction, across the middle of the samples, bending was performed to cause compression on the space exposed surface of the FEP layer. Perpendicular to the compressive fold line, the FEP was bent so that the space exposed surface was subject to tensile stress. Each fold direction was subject to 25 cycles. The results indicate that compressive folding had no observed effect on the materials. Tensile folding induced cracking in the material for the samples with high solar exposure (see Fig. 15). No cracking was observed for the samples with the lower solar exposures.

Figure 15: SA-I MLI FEP layer subjected to the tensile bending. This sample received the highest solar exposure. (a) Sample prior to bending. (b) Sample after the tensile bending.

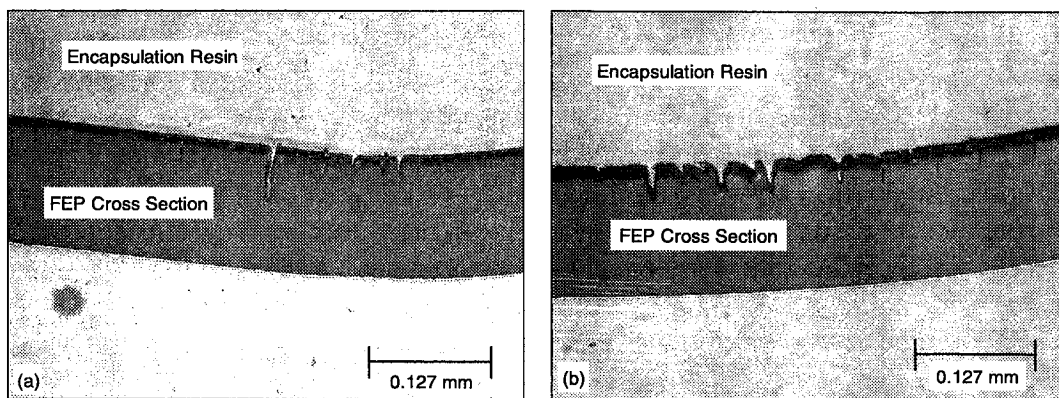
Figure 16: Cross sectional micrograph of the magnetometer FEP. Both thicknesses are measured to be 0.113 mm. (a) Sample removed from 11,339 ESH area of MLI, adjacent to the 16,670 ESH area. (b) Sample removed from the 16,670 ESH surface of the MLI.

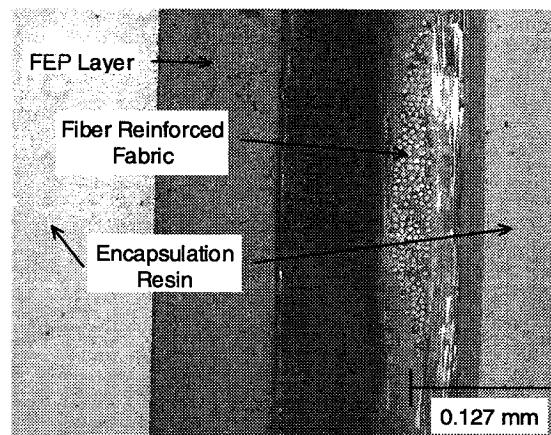
Figure 17: Cross section of the SA-I MLI FEP layer from an area of high solar exposure.
